## Notes on Intel Microcode Updates

Ben Hawkes <hawkes@inertiawar.com>

December, 2012 - March, 2013

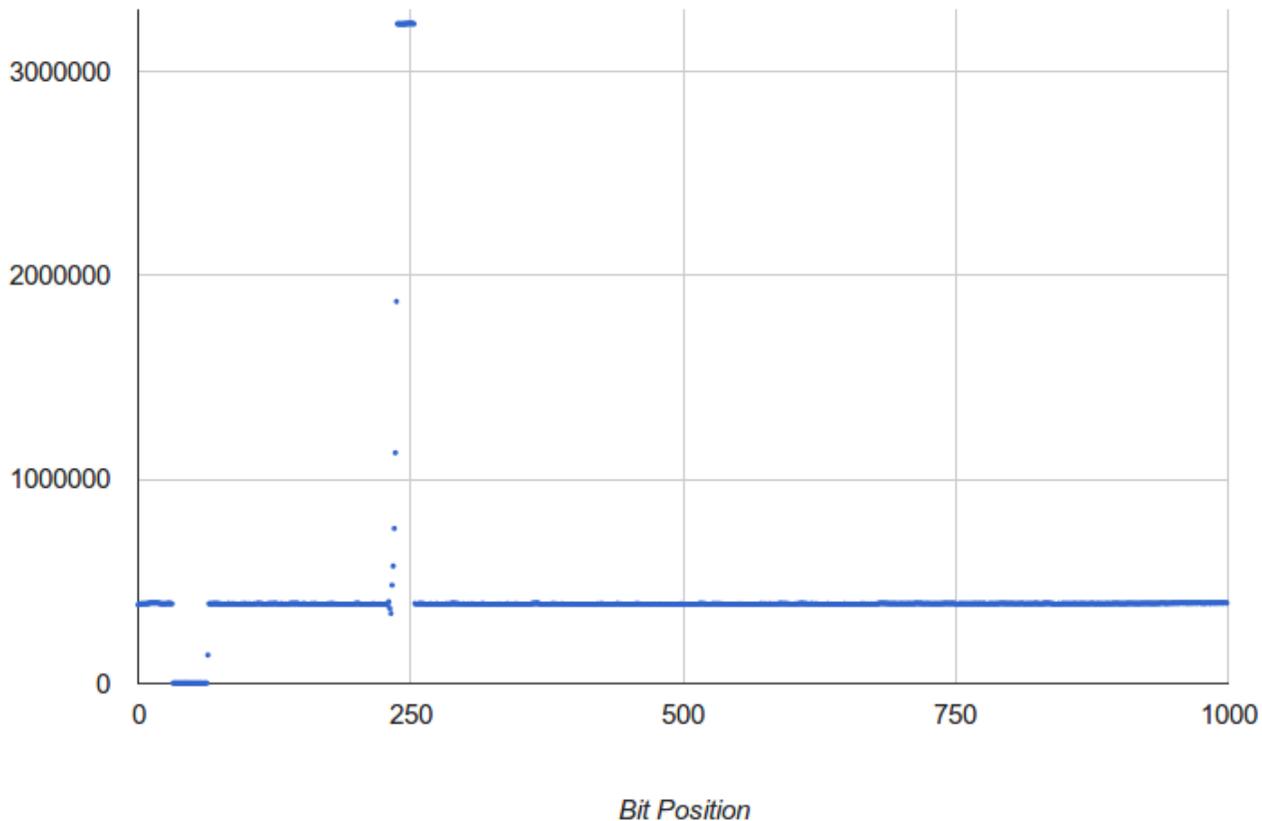
**Fig 4 - Fault Injection Timing Analysis**

Running this test on an Intel Core i5 M460 gives the following results:

This chart shows the results of the first 1000 bit positions being flipped. Three distinct areas of interest can be seen. All other bit position above 1000 return a cycle count matching the failure case seen above.

The first area of interest, between bit offsets 32 and 63, corresponds to an unknown word the in the 96-byte header that always has value 0x000000a1. This may serve as a magic value, checked when the microcode is first loaded to ensure that an expected format has been received.

The second area of interest is a single bit at offset 64, which appears to correspond to a flags field. In the original analysis, this bit was set. However, clearing the bit and repeating the analysis shows identical results to figure 4, except with a significantly lower average count of cycles for the "normal" failure case. The decrease in cycle count appears to be proportional to the number of physical cores on the system, which may suggest this bit is used to decide whether the update will be iteratively applied to all cores, or only applied on a single core.

The third area of interest, between bit offsets 233 and 253, corresponds to the microcode size field.

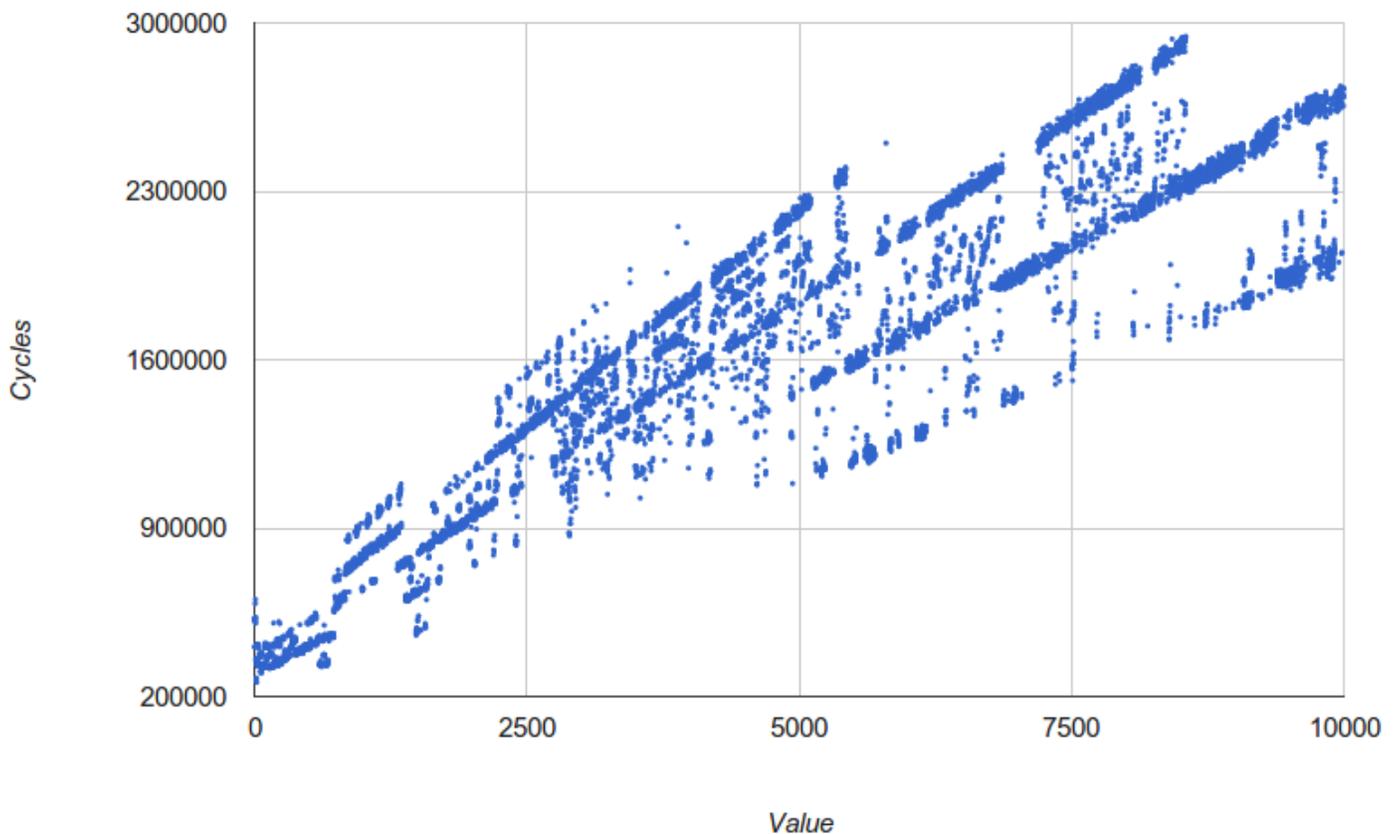
**Fig 5 - Microcode Size Modifications**

Modifying each bit position results in an incrementally higher cycle count. To investigate this further, a second analysis was run that records the cycle count for each size value between 0 and 10000. The following shows the results of this analysis on an Intel Core i5 2520M:

In this chart we can see a clear correlation between an increasing size value and an increasing cycle count. This chart appears to also show artifacts from running this system on a multi-core system (note that the i5 2520M is a quad core processor, and that four main trend lines can be seen).

Running the size modification analysis with an incorrect magic value (i.e. replacing 0x000000a1 with a different value) results in a flat chart with no correlation between value and cycle count. This suggests that the magic value is checked prior to the size value being used.

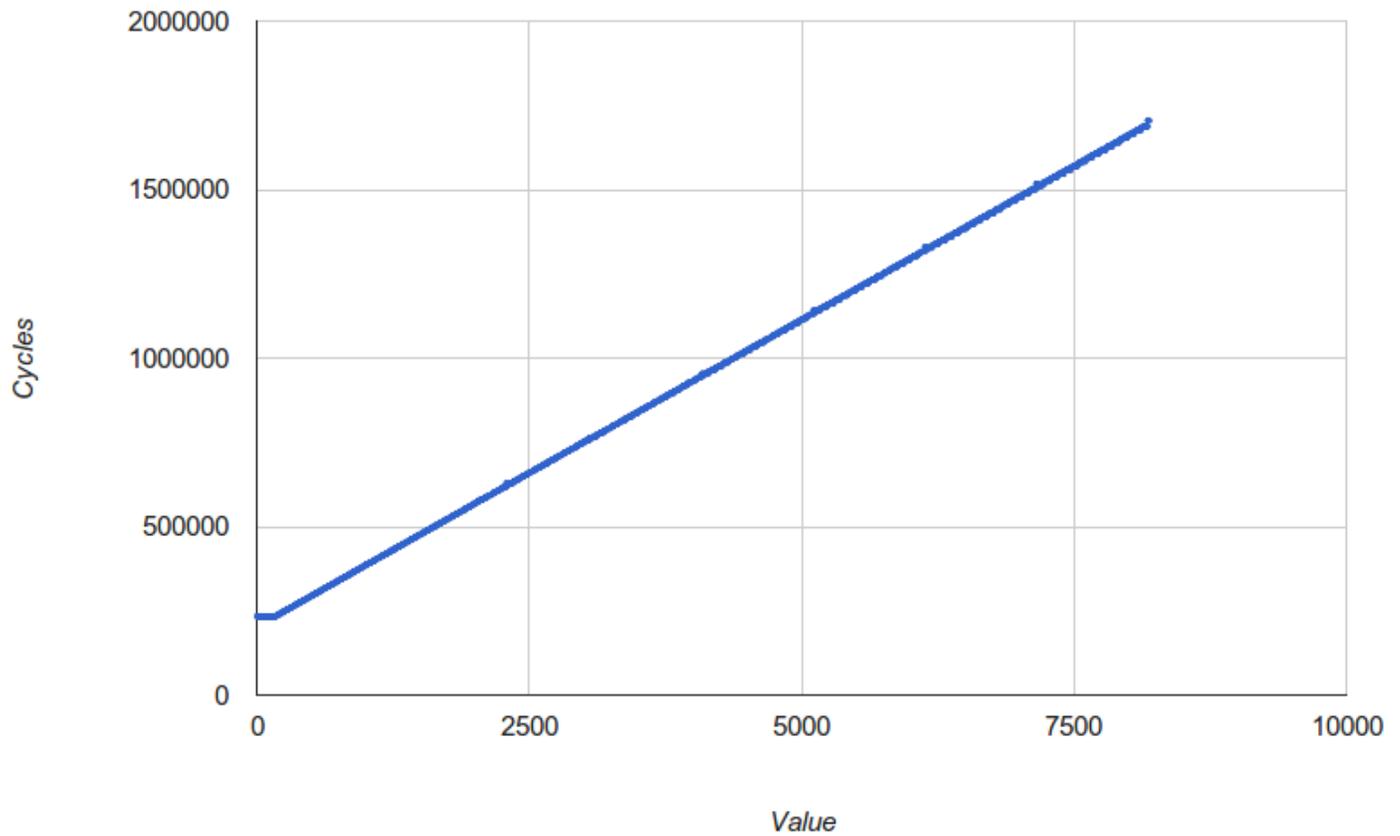
**Fig 6 - Microcode Size Modifications (single core)**

Due to the high level of noise while running this analysis on a multi-core system, the analysis was rerun with symmetric multiprocessing (SMP) and HyperThreading disabled. A clear linear correlation between length value and cycle count is seen. The follow data is taken from an Intel Core i5 2520M:

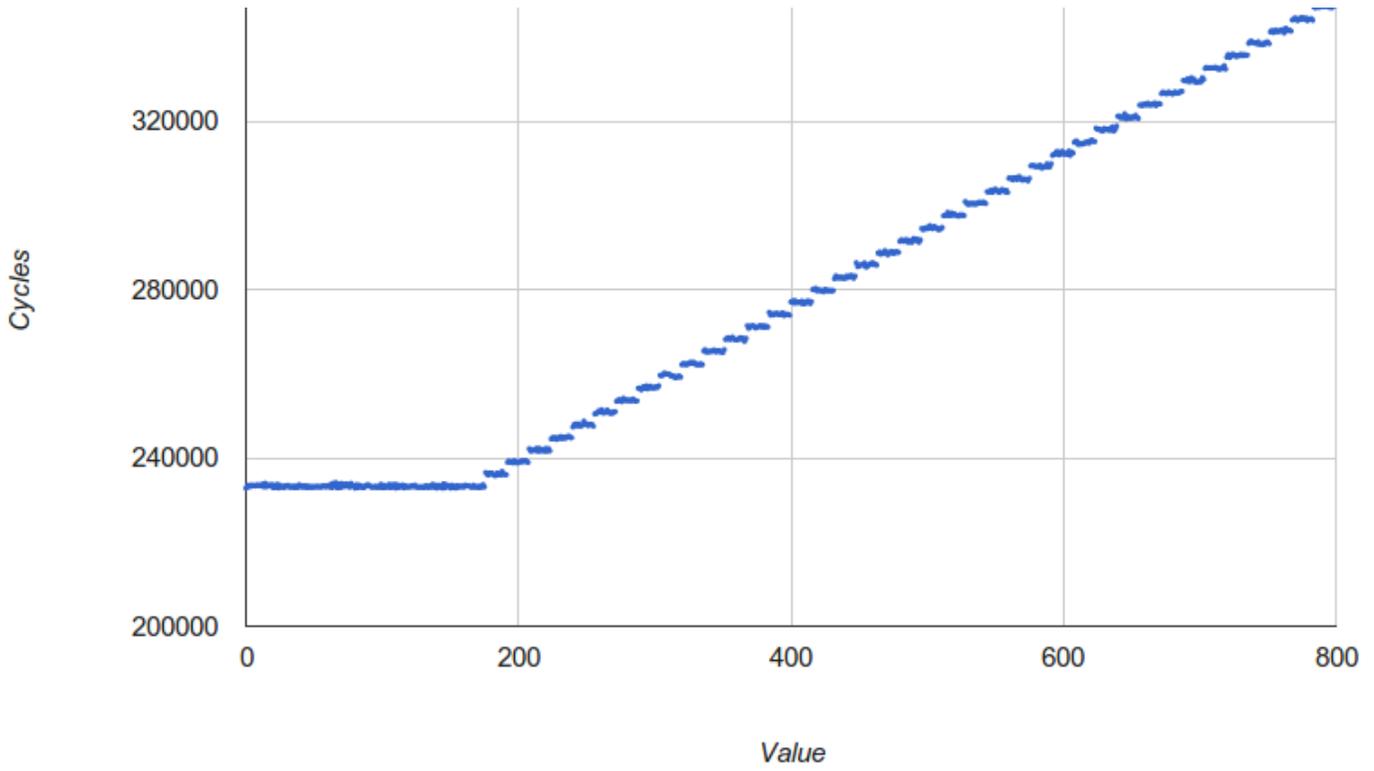
**Fig 7 - Microcode Size Modifications (single core)**

With this cleaner data, it is possible to observe new timing behavior. By displaying a smaller sample, clear timing shelves are seen as the size value increases:

By observing the individual points of the timing shelves, it is clear that each timing shelf has 16 points. Since each single increase in size value corresponds to a 4-byte increase in microcode data, 16 points represents 512 bits of data.

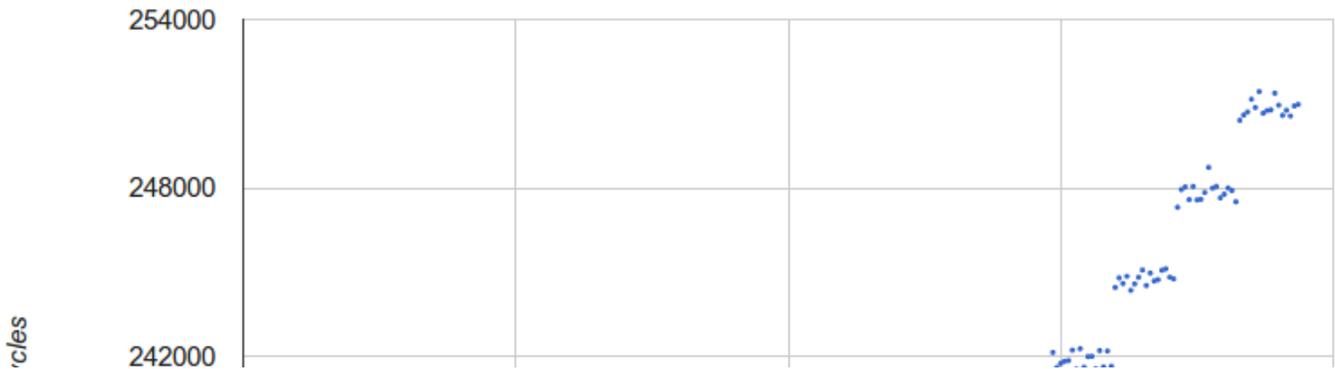
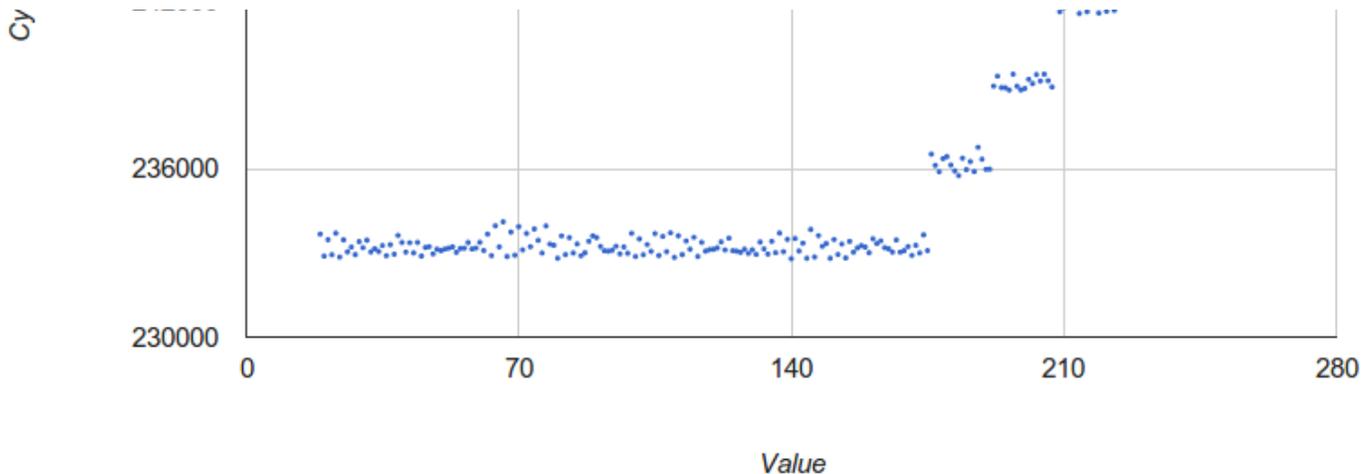
**Fig 8 - Microcode Size Modifications (single core)**

512-bits is the standard message block size for popular cryptographic hash functions such as MD5, SHA1 and SHA2. The timing shelves observed match what we would expect from a Merkle-Damgard hash function, as each new shelf represents the increase number of cycles required to process a new message block.

In public-key signature schemes, it is normal to sign a hash of the data message instead of signing the entire message contents. This means that a hash operation being observed in the early stages of the microcode loader process is an expected result.

Note that the first shelf is observed after supplying a size value of 176 (or 704 bytes of microcode data), and that supplying a size value of 704 bytes or less results in a constant timing shelf. This would suggest that there exists a minimum length of non-variable-length data that will be hashed regardless of the supplied microcode size field. This data includes the undocumented microcode header and the RSA public key that has been discussed above.
